## FATIGUE (not STRESS) CRACKS

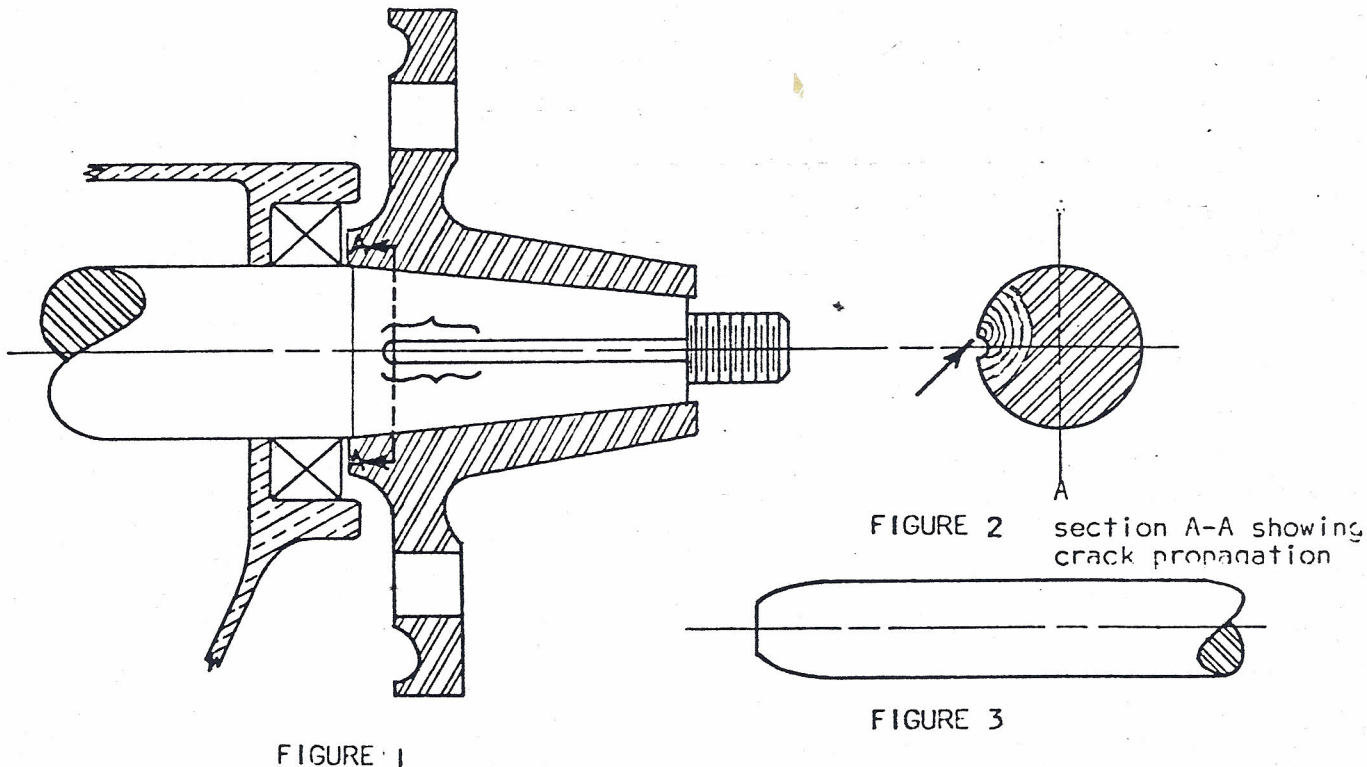
Elans which have been raced a lot have a bad habit of shedding rear wheels. This occurs because of fatigue cracking of the stub shaft. The axle shaft usually fails  $1/16$  of an inch outboard of the hub (see fig. 1.). A crack starts on the side of the shaft where the groove for the dowel pin is, and then progresses across the full diameter of the shaft, little by little, as the shaft is exposed to more cycles of bending under heavy cornering.

It is thought that this failure occurs here because of the combined effects of (1) the taper in the shaft ( which begins just inboard of the failure point), (2) the notch left in the bottom of the dowel groove by the sharp end of the dowel, and (3) the sharp edge (arrow in fig.2) left when the dowel groove is cut into the shaft.

The proposed solution is to (1) round the end of the dowel ( as shown in fig. 3), (2) round the sharp edge of the dowel groove for the first  $1/2$  to  $5/8$  of an inch (brackets in fig. 1.), (3) remove the notch from the bottom of the dowel groove, and (4) shot peen. Of course, these modifications will not save a part which has already begun to crack.

It is also recommended that racers periodically pull their rear hubs, polish the critical area with 500 or 600 sandpaper, and visually inspect for cracking. The cracking takes many hours of high speed cornering to pass across the diameter of the shaft, and so can usually be caught by a regular inspection program.
