LOTUS ELAN FRAME REPAIR

Tom Dill
(dwg. by JFK)

INTRODUCTION

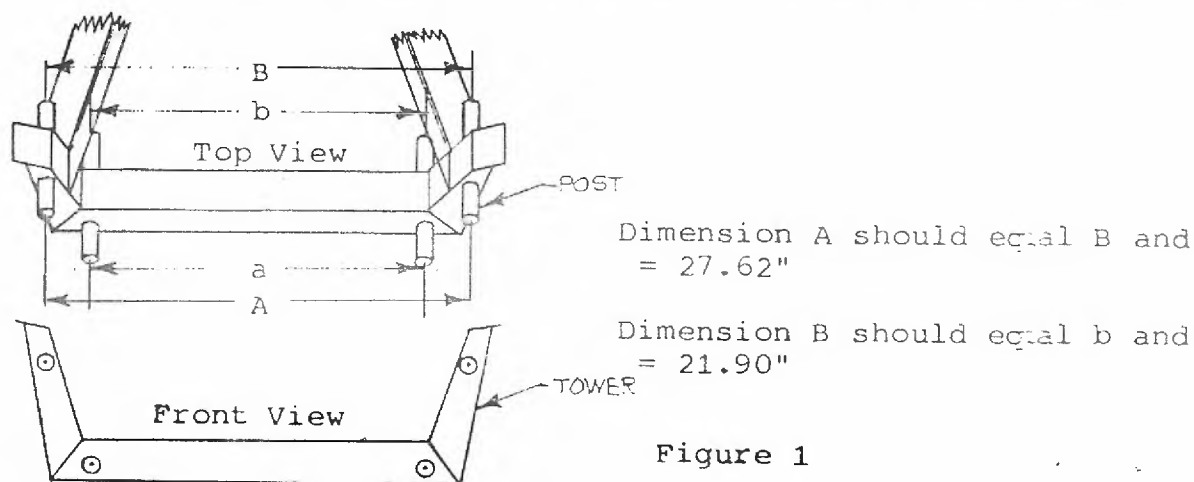
A major defect was twisted towers such that the dimensions between the "A" arm posts were off. This is illustrated in Figure 1.

Dimensional differences were found on the apparently good frame of 3/4" on the top posts. The upper posts themselves were not bent; (they were perpendicular to the base where welded), therefore, the towers needed "trueing" to regain proper alignment. I used heat and a steel

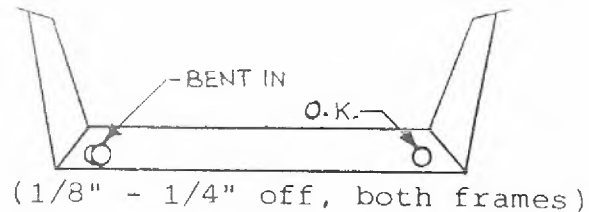
Figure 3

The dimensions on the lower posts were generally good, but I found that the bottom posts are subject to misalignment, possibly due to impacts. See Figure 3. They are "soft" and can be rapped with a copper hammer after protecting the threads. You can make or use a carpenter's square to check.

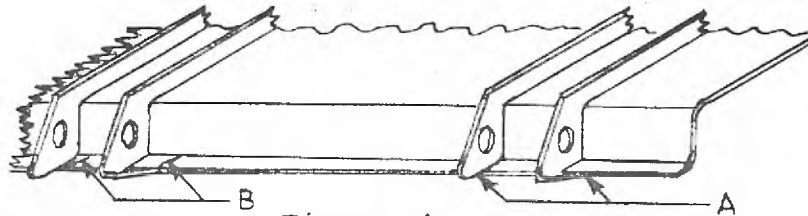
Figure 4

The tabs which are welded to the frame to accept the rear "A" arms have actually been torn off slalom Elans! I can visualize this happening. Check for poor welds at the position shown by A in Figure 4. Such welds do not run continuously from tab to frame, but stop abruptly or dip in and leave an open, non-reinforced trough through which stress can cause the general area to weaken via work hardening.

Whether the welds are good or bad, check in these areas for hairline cracks running inward on all four tabs, as shown at B in the Figure. Prepare and fix with good welding procedure: Clean, groove, and weld. Check often under the car! This is one repair that can be made safely with the body in place. A good muffler man could probably handle this one, but the "A"-arm eyes may fry if you are not careful.

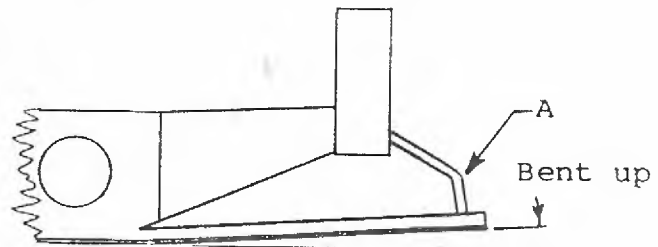
Figure 5 (angle exaggerated)

The bottom channel where it leaves the boxed section of the frame rearward is subject to upward bending, as shown in Figure 5. The frame I corrected was off 1".

Another clue to this bent condition is difficulty extracting the differential unit due to insufficient vertical clearance.

This is a difficult correction. I finally resorted to heating the two downward braces at point A and striking that point from the outside, thus causing the channel to realign itself. These supports are solid and are difficult to heat. I considered using a small hydraulic jack but didn't have one. I was also leery of applying force to the other pressure point, in this case the bottom of the cross-section which houses the differential mount holes.

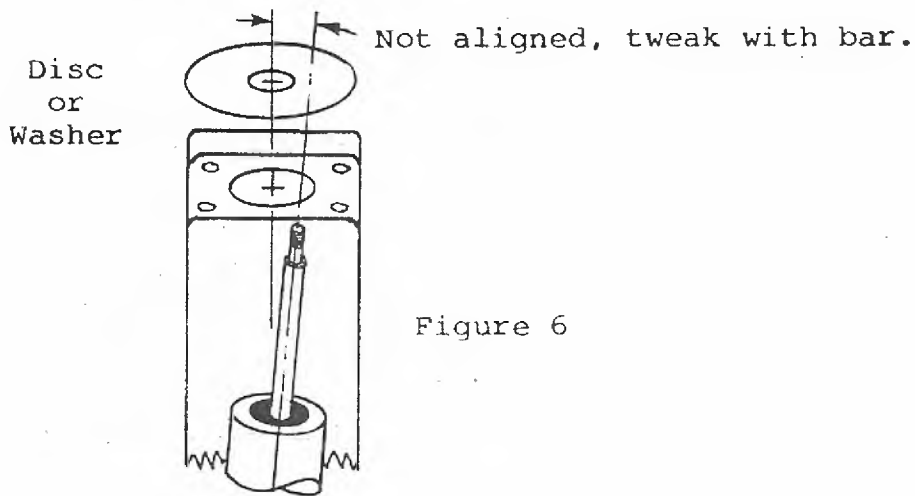
These towers are subject to the same type of twisting distortion as the front towers. If you know your rear "A"-arm assembly and shock tower are straight, use them as a test fixture and see if the shock shaft is at the centerline of the upper mount flange area. See Figure 6, next page. Make a disc or washer to allow a closer check of the shaft centerline to the mount flange. Check for spread and front to rear tower dimensions also. To correct see the later discussion of correcting tower damage.

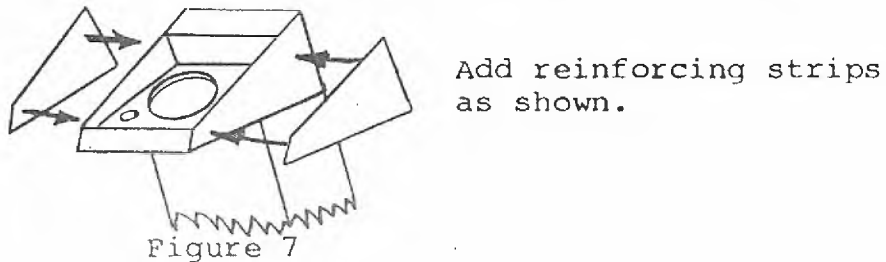
Some Elans are used so hard without adequate rear suspension travel or with excessive bottoming that the whole mount flange is bent upwards until it contacts the underside 'glass panel. See L/W Tech Article 26MC065. Use mild steel sheet or light plate and reinforce the sides after straightening. Don't go too wide or you'll have trouble with clearance of the new top in the glass enclosure. Figure 7 shows the location of the reinforcing sheet.

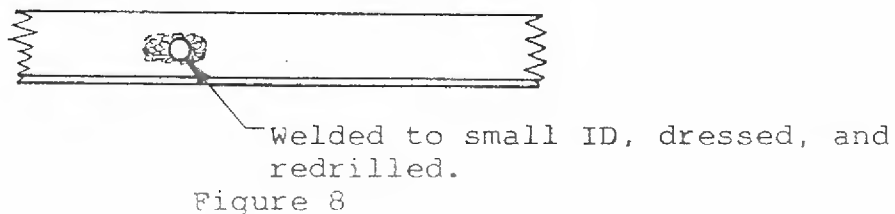
The small hole which is the forward mounting point for the differential torque rods may be elongated due to loose fasteners hammering back and forth. Weld-fill and redrill.
