ELAN
1973 LOTUS CLINIC ANNUAL

BODY & INTERIOR

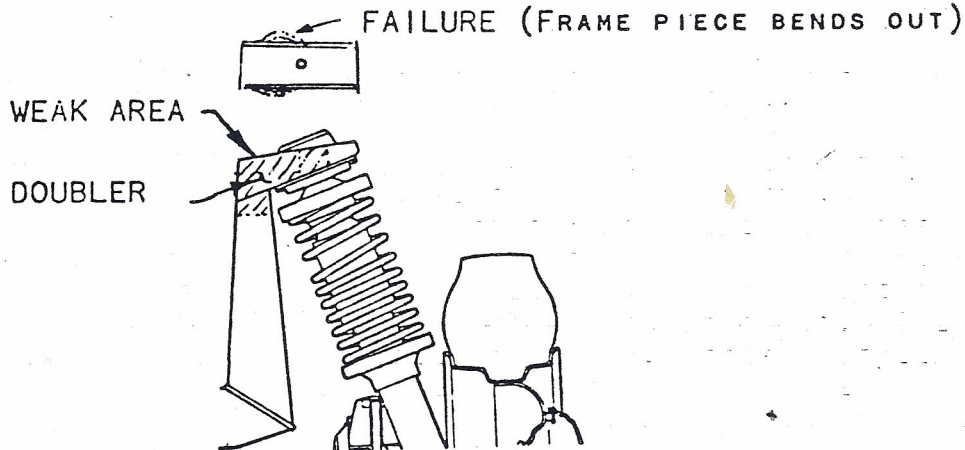
ANYONE WHO REMOVE THEIR ELAN BODY MIGHT CONSIDER REINFORCING THE FRAME MEMBER WHICH SUPPORTS THE REAR UPRIGHT. SEVERAL INDIVIDUALS HAVE HAD THIS AREA CRIPPLE AFTER INSTALLING STIFFER SPRINGS AND SHOCKS. THE WELDING OF A DOUBLER ABOUT THE SAME THICKNESS AS THE ORIGINAL MATERIAL IS RECOMMENDED IN THE AREA SHOWN BELOW.

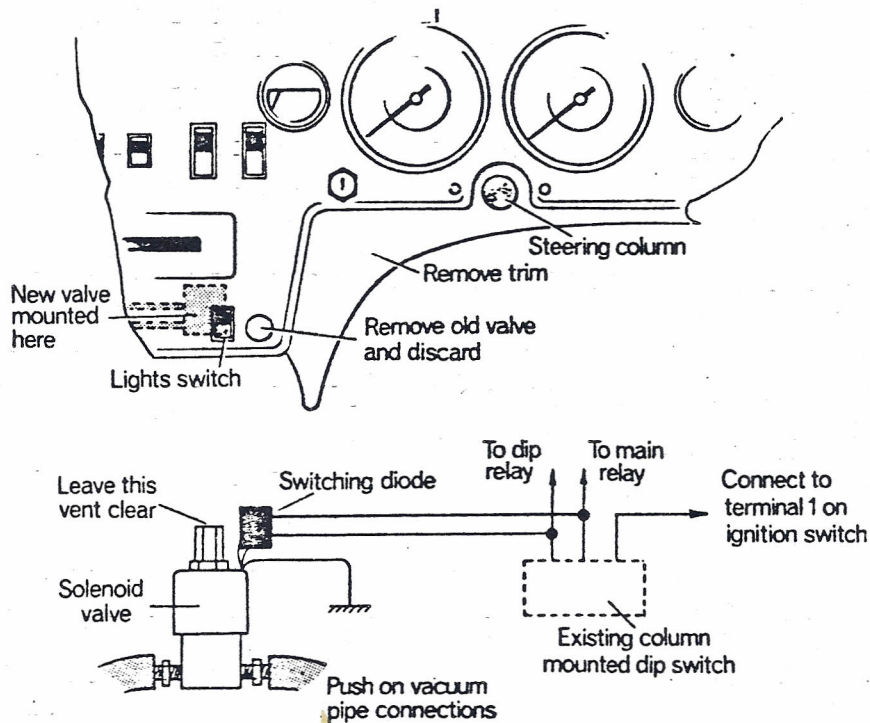
Many testers criticise the Elan for its awkward headlamp flashing arrangement, or lack of it. These difficulties may be resolved by fitting a solenoid vacuum valve which raises the lights automatically whenever the filaments are lit.

The existing system is controlled by a push-pull valve located on the right of the dashboard. Access to it is via four screws. The knob should be removed, its retaining nut undone and the two rubber vacuum pipes pulled off the valve ports. The valve can then be discarded and the pipes reconnected to the solenoid version. The black lead should be earthed and the red leads connected to the Blue/White and Blue/Black ones that come from the dipswitch and emerge from the steering column where it passes through the fascia. To bring the normally redundant flasher section of the dip/flash switch into operation, the brown lead (found by the Blue/White and Blue/Black ones) should be connected to terminal one on the ignition switch.

The solenoid valve used in this modification is a Skinner-Europa C5DK1060 solenoid vacuum valve. LAB Engineering Ltd, PO Box Whitley Bay, Northumberland, NE25 9RS, will post you a valve with integral diode logic and pipe connections for £6.95.
