# Lotus Elan +2 Engine Rebuild

## Part 1: Dismantling — the horror story, by Miles Wilkins.

## *Part 2 Machining, reassembly, and more straight talking from Miles Wilkins.*

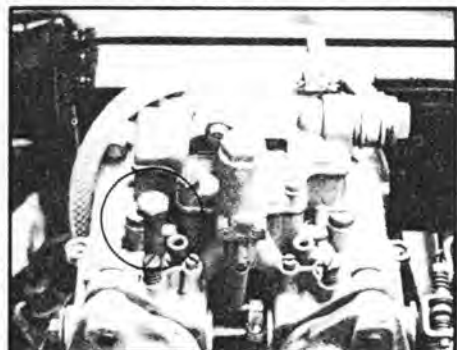
*The bolt is not standard on No. 1 carb barrel! Braided fuel line should never be used as it hardens with age and becomes brittle and will eventually crack. This type of piping is the cause of many fires on cars.*

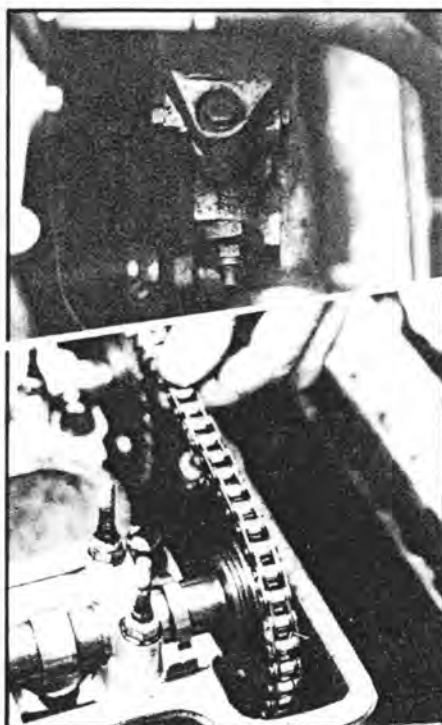
*The timing chain tensioner is well in, indicating a worn chain. The ends of the threads are damaged as well. The chain is too loose, 1/2" total deflection at this point is the correct measurement.*

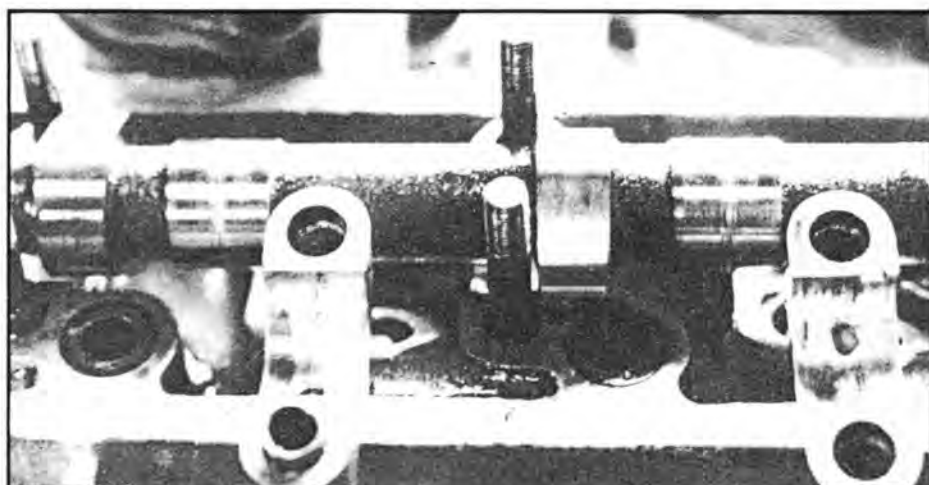
Both camshafts and all bearings ruined by the metal swarf and sand grit being pumped around. The oil pump will be thrown away as this was too badly scored.

was not cleaned out and the remains of the sand and metal swarf were responsible for ruining both camshafts; the bearings and the main and big-end bearings were scored to the copper as well.

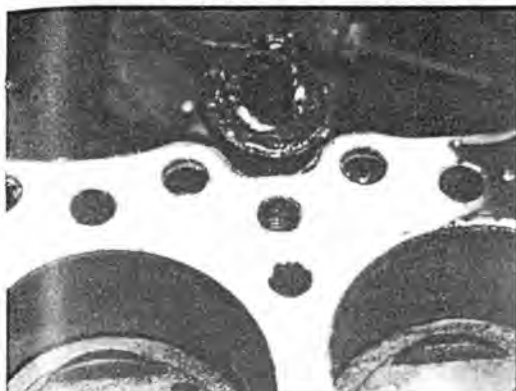
One cause of the oil slick under the car; the head to block rubber was not properly located in the head — a legacy from the last effort — allowing the draining oil to run out. The other cause was an incorrectly fitting rear oil seal.

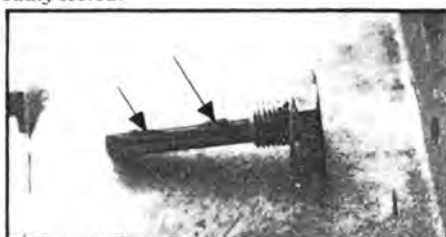
The timing chain bracket pivot badly worn (arrowed).

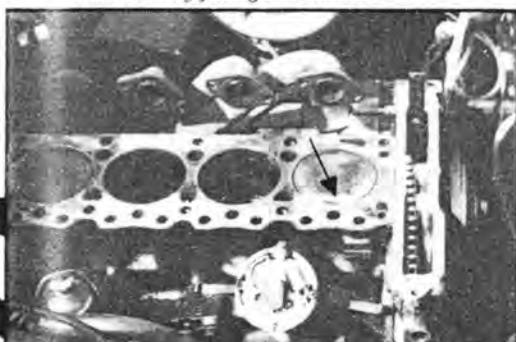
A general view showing the shiny mark (arrowed) on No. 1 piston where the valve had been hitting. There should be the correct cut-out rotor arm fitted, this standard one will be replaced. Note the high build up of oil coke in the manifolds.

undone and the head lifted clear. We were appalled at what we saw; all inlet valves were hitting the pistons (this explained the knocking noise). The pistons (standard) were so slack in the bores that we initially thought that some idiot had rebored the block 20 thou and fitted std. pistons; upon subsequent measurement we weren't far wrong as there was an 18 thou gap (piston/bore clearance should be 3/3.5 thou). Two bellhousing bolts were missing and the starter motor was held on by one 5/16th nut and bolt through a 3/8ths hole. Needless to say this explained the awful clanking noise when starting; the ring gear was smashed to pieces. The starter motor was the wrong one anyway, being a three bolt fixing with a 10 tooth pinion instead of a two bolt fixing and a 9 tooth pinion. After all the bellhousing and engine mounting bolts were undone the block was lifted out of the engine bay revealing a heavily scored bellhousing — something had been bouncing about in there. The head was dismantled first and from here on it is a sad tale of woe, so I shall digress with another lecture coming up! Everything looked too clean inside the engine for 70,000 odd miles and many components looked as though they had just been changed; the valves etc. were all too new. The photographs show the mess.

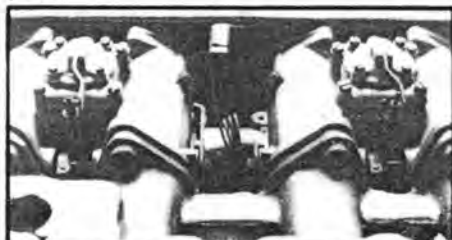
The throttle diaphragm levers are set completely wrong. The rear carb was pumping in its fuel way before the front one. There were two spring washers instead of Thackery washers holding the carbs on.

The engine was painted in the correct Lotus grey (not red, yellow, pink or blue - they were grey when they left the factory), and then the ancillaries were fitted, namely the fuel and oil pumps and the distributor. The carbs were overhauled next; completely stripped down, cleaned and reassembled with all new gaskets and seals. New pump diaphragms, springs and rods were required (see part one).

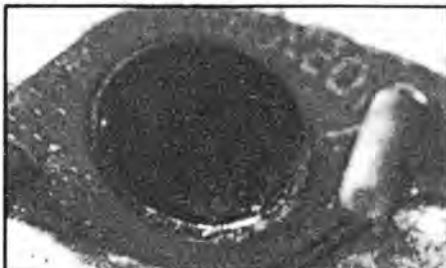
Note the oil trace in the port where the oil has been pouring out because of over-reamed guides.

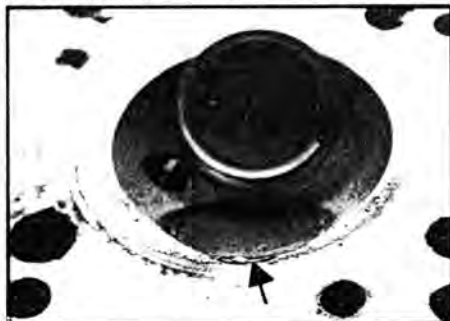
The exhaust seat also on No. 1 was fitted badly as well. Note the gap (arrowed) between the seat and the head, presumably where someone had tried to force the old seat out.

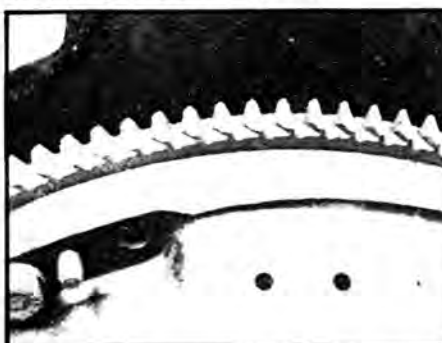
With the wrong starter motor held on by one bolt it is hardly surprising that the ring gear is smashed up.

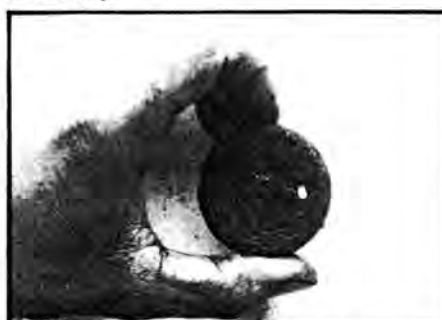
Block core plugs are automatically changed by us on every rebuild. Only a build up of rust and Bars Leak prevented this rear plug from leaking.

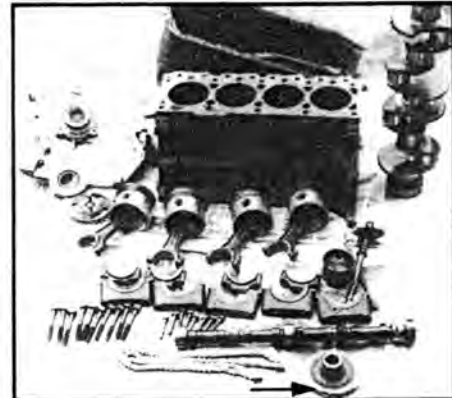
pistons and crankshaft were removed. The latter will certainly have to have the main journals ground, the big ends may just survive with a polish. It took 8 hours to reach this stage.

The bottom end laid bare. Note the front pulley flange (arrowed) all broken away. The crank suffered deep scoring on the main journals — these will have to be ground. The big end journals may survive with a polish.

The first task entailed all the machining; the block was rebored to +20, new jackshaft bearings fitted (reamed to the jackshaft), and then the block face was checked for any distortion. The crankshaft and con-rods were crack tested (all passed), and the crankshaft was reground +10 on the mains, but fortunately the standard big-ends survived with a polish. New small-end bushes were fitted to the con-rods and reamed to the new gudgeon pins.

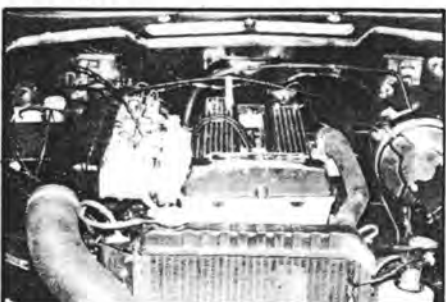
All back! Note the new braided fuel line, and new brake servo. All water hoses were replaced as well, since all were perished.
