## TWINCAM VALVE STEM SEALS

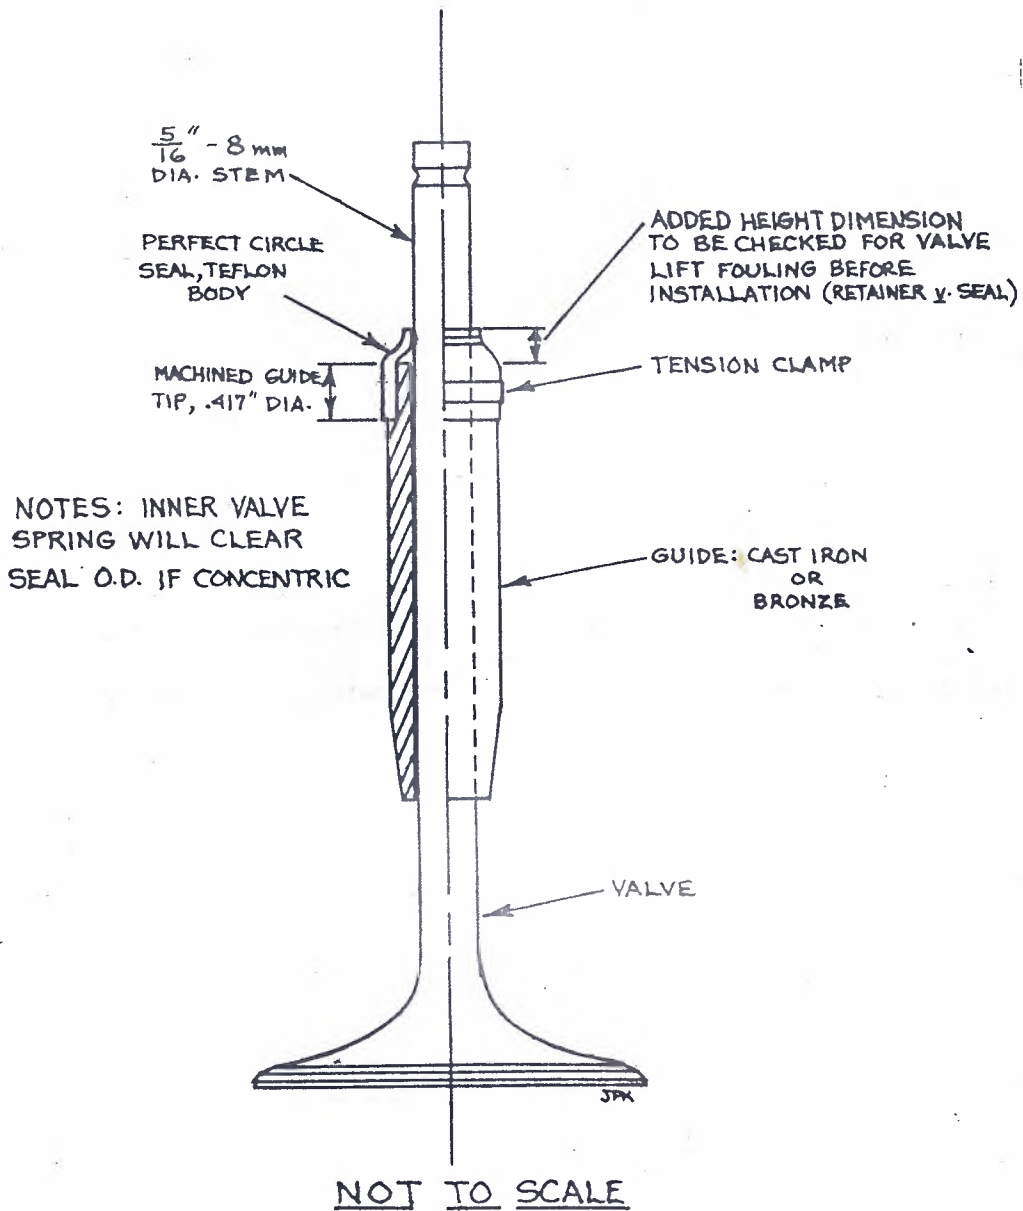
To install, major work is necessary, including machine shop time. The old guides must come out and most likely will be ruined. Bronze or cast iron standard ENFO guides must be machined from 0.500" OD to 0.417" to a depth suitable to accept the body of the seal and its metal spring clamp. The guides are then installed without seals, seats reground, and, finally, seals pressed on from the top. These seals have been used with cam lift of up to 0.400". At this lift, retainer to seal clearance gets very small, however.

It is recommended that before performing these instructions, some measurements be made on several stock set up valves/springs with depth gauges or machinist blue to be certain the necessary clearance will be achieved. Some clearance may be gained by relieving the retainer bottom or slightly repositioning the guide depth. The latter may involve new circlip grooves. Some shops specialize in this type of work, but may not be familiar with the intricacies of the TwinCam head.
