HEADLIGHT VACUUM POT

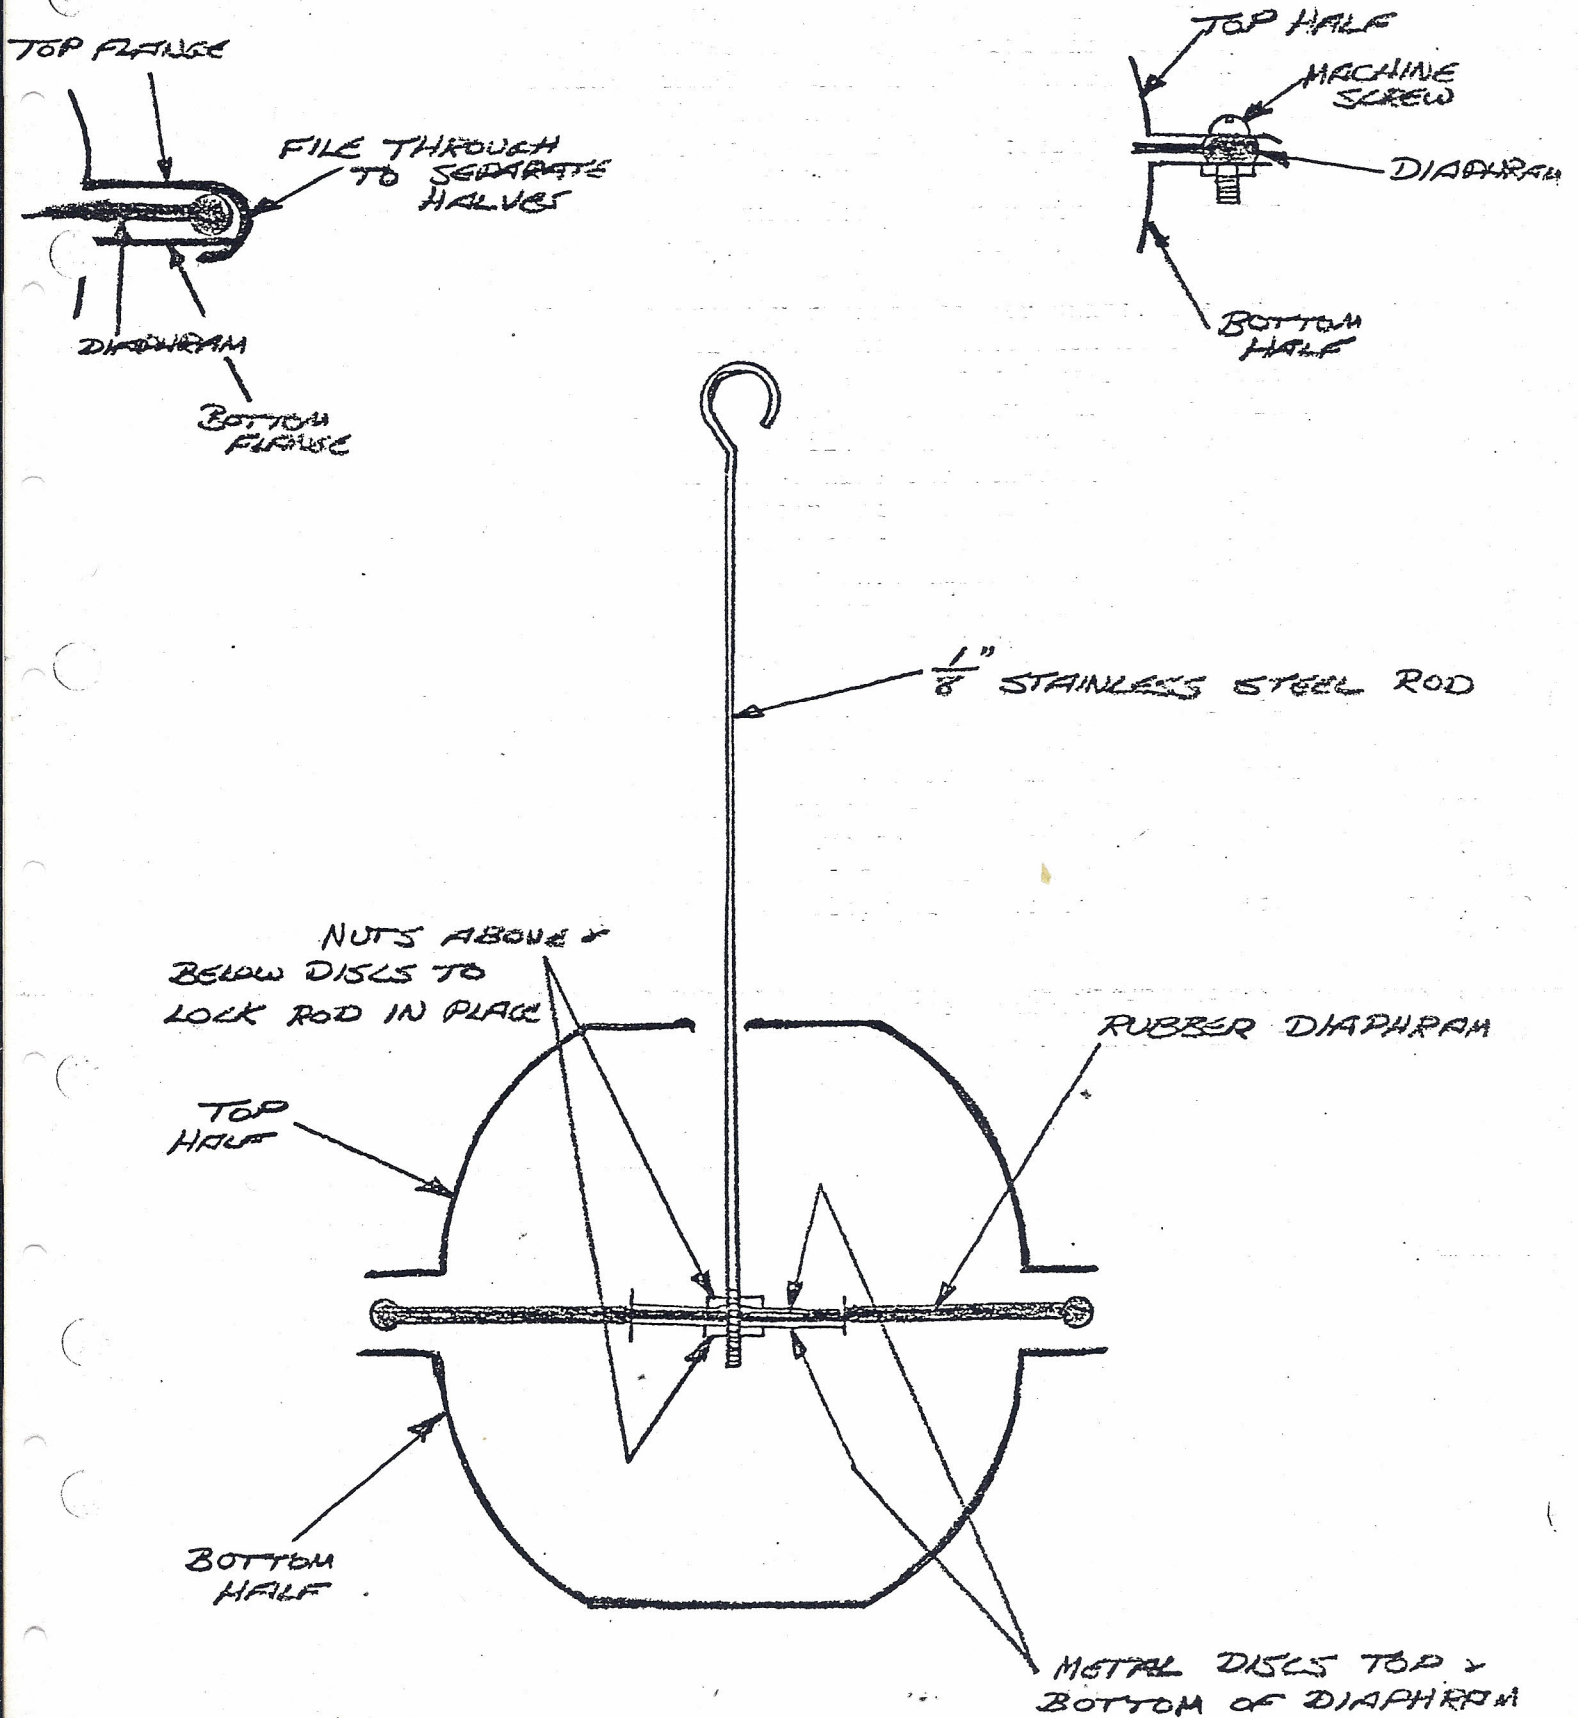
The pot consists of two halves with a rubber diaphragm held between them. The headlamp actuating rod is screwed and bolted to a metal center in the diaphragm. When the dash switch is pulled a vacuum is drawn on the bottom half of the pot pulling the diaphragm and activating rod down thereby pulling the headlamp up. (These English are clever chaps, what?)

The pot halves are crimped together and are separated by filing (coarse bastard file) or grinding the outer flange (see diagram). Only about 1/32" of material is removed from around the entire flange perimeter (the writer accomplished this with a bastard file in about 20 minutes).

This writer's failure was a rusted through activating rod. It seems in some Elans the pots collect water in the top half through the activating rod hole. My pot was almost full of water when the rod broke off. Some owners have poured a silicone lubricant in the pot top hole to inhibit rust and protect the diaphragm. If a broken rod is the problem cut off the remaining stub and file as flush as possible to the metal disc (careful to avoid abrasion on the diaphragm). Drill a 1/8" hole through the center of the disc. A stainless steel rod 1/8" diameter and approximately 13" long is threaded on one end about 3/4" up from the end. A nut is screwed on to act as a stop. The rod is then put through the disc and secured by a second nut at the bottom. Loctite is used to secure the assembly. After smearing a gasket seal material on the bottom flange of the diaphragm and inside flange of the bottom pot half, place the two together. Replace the top pot half and secure with "C" clamps. While clamped in place drill holes at 3, 6, 9 and 12 o'clock through the flange as close to the edge as possible to accept small diameter machined screws with washer and nut (see diagram).
