## Throttle Pedal and Cable Maintenance

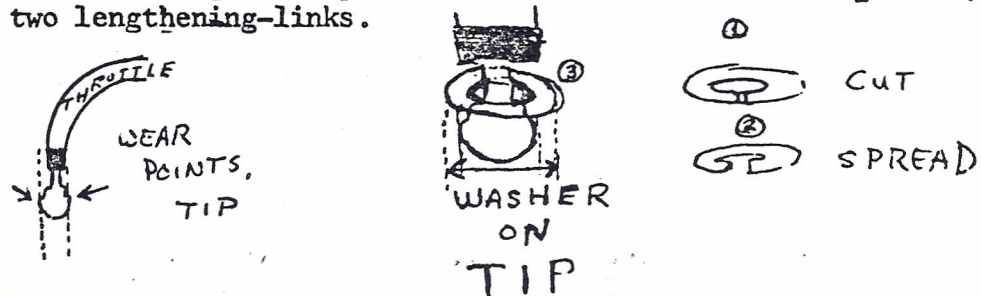
Finally, if you have wished for better brake pedal-throttle pedal proximity for heel-toe driving it is possible to lower the throttle  $\frac{1}{2}$ " to  $\frac{3}{4}$ " by merely making two lengthening-links.
